“Lord Willing n’ the Creek Don’t Rise”

Flood Sustainability at Harpers Ferry National Historical Park

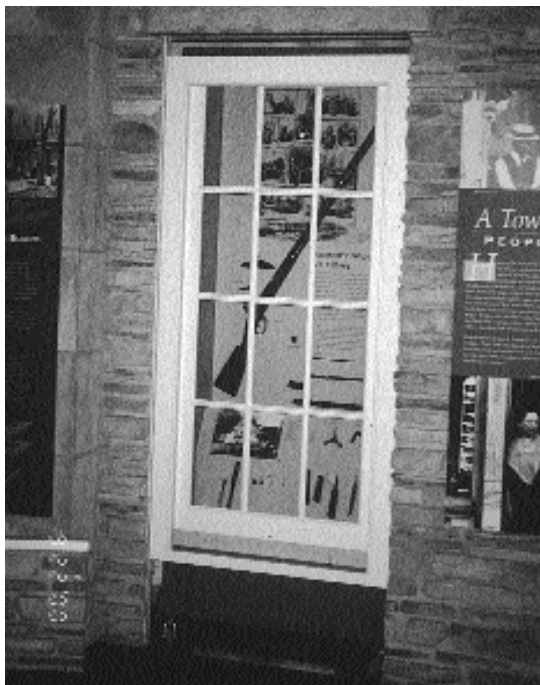
Museum exhibit case ready to be wheeled from building after removal of decorative base plate. Photo by the author.

Another innovation in this exhibit involves the design of exhibit cases. Several of the cases sit on wheels that remain hidden behind decorative panels seen by the visiting public. In the event of a flood, these panels can be unlocked and removed, thereby allowing the cases to be wheeled to a truck and transported to higher ground for safe keeping.

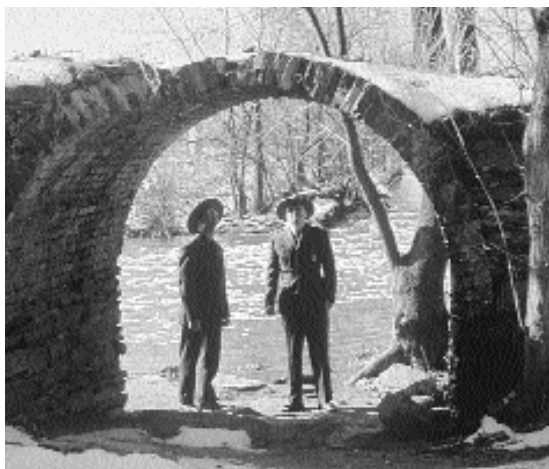
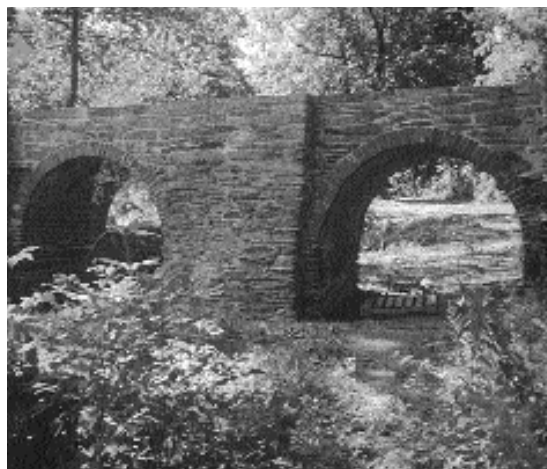
Left, Virginius Island water intake arch in jeopardy of collapse after losing its structural load, photo courtesy NPS. Right, same arch following stabilization work completed during 1996 flood recovery program, photo by the author.

During the 19th century, a series of water intake channels was instrumental in directing water from the Shenandoah River into tunnels leading to the small factories on Virginius Island. Prior to the 1996 floods, the water intake arches were close to collapsing, the tunnels had been completely filled with silt and other flood debris, and the foundations of historic mill buildings had deteriorated to the point where their total loss had become a realistic possibility. The funding provided by Congress following the 1996 floods made it possible to reopen the tunnels and stabilize the arches and foundations. These steps have ensured that the water distribution system will be visible to the public and incorporated into the park's interpretive programs for decades to come.

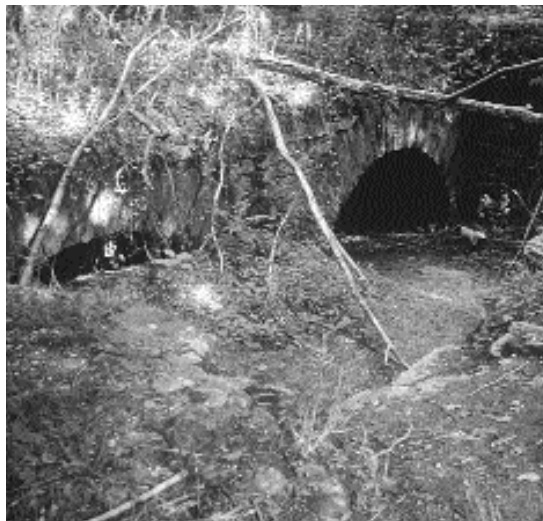
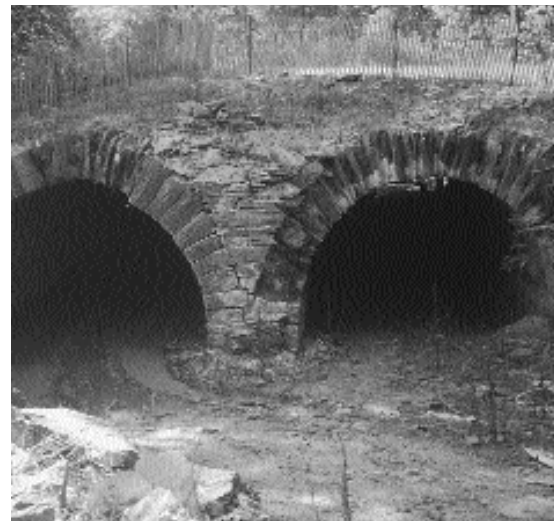
Left, water tunnels on Virginius Island nearly filled with flood debris, photo courtesy NPS. Right, same tunnels with debris removed as part of the 1996 flood recovery program, photo by the author.
